# Pedestrian Signal Safety for Older Persons

Edward R. Stollof, AICP  
Co-Principal Investigator  
Institute of Transportation Engineers

AAA Foundation for Traffic Safety  
607 14th Street, NW  
Suite 201  
Washington, DC 20005  
800-993-7222

[www.aaafoundation.org](http://www.aaafoundation.org)  
July 2007

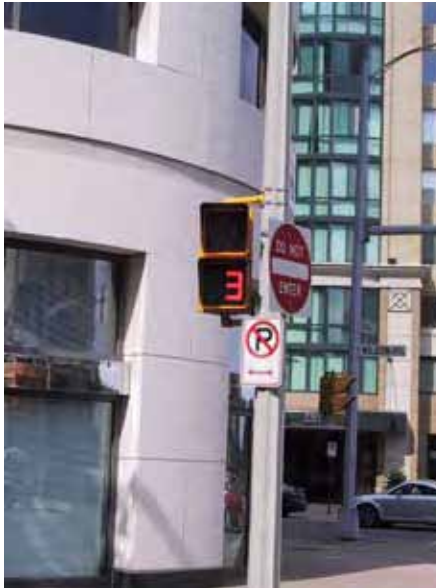
**Figure 1.** Example of a pedestrian countdown signal.

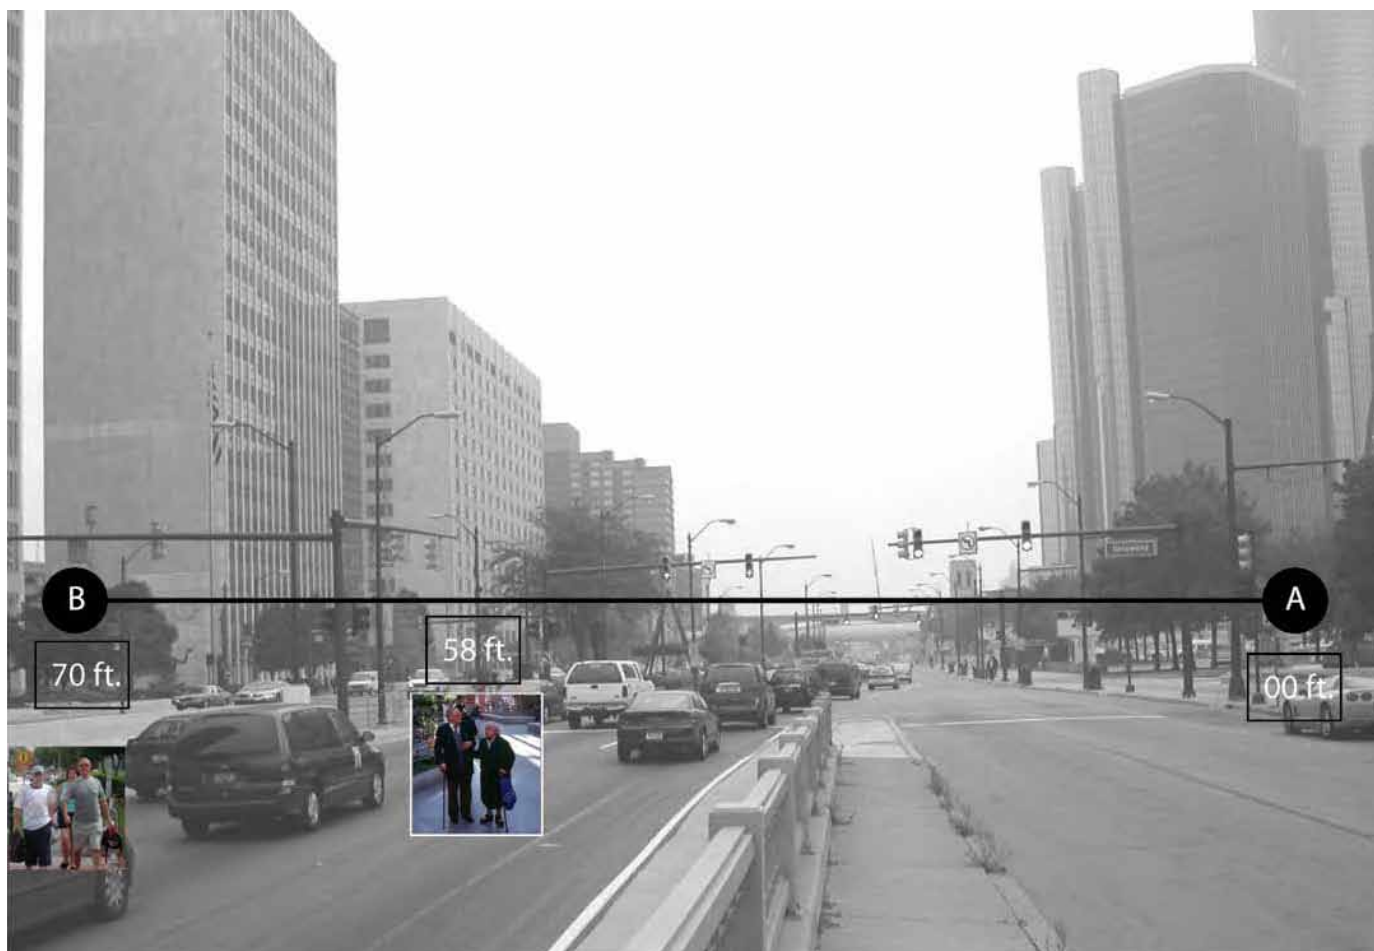
**Figure 2.** Senior Showcase Driver Roadway in Detroit, Michigan. Presentation to the North American Conference on Elderly Mobility, September 12, 2004. Source: Kimberly Lariviere. Photo overlay: Edward Stollof. Note: Map not to scale

Figure 2 illustrates how important establishing adequate signal timing for pedestrians can be. This figure shows a 70-ft. street crossing from point A to point B. Given that older and younger pedestrians walk at different speeds, where will the older pedestrian be when his/her younger counterpart reaches the far curb?

Assuming that the younger pedestrian walks at 4.00 ft./sec. (the speed prescribed by the current edition of MUTCD) and the older pedestrian walks 0.70 ft./sec. slower, the older pedestrian would have more than 12 feet to walk—or another whole lane to cross—when the younger pedestrian had successfully crossed the street.

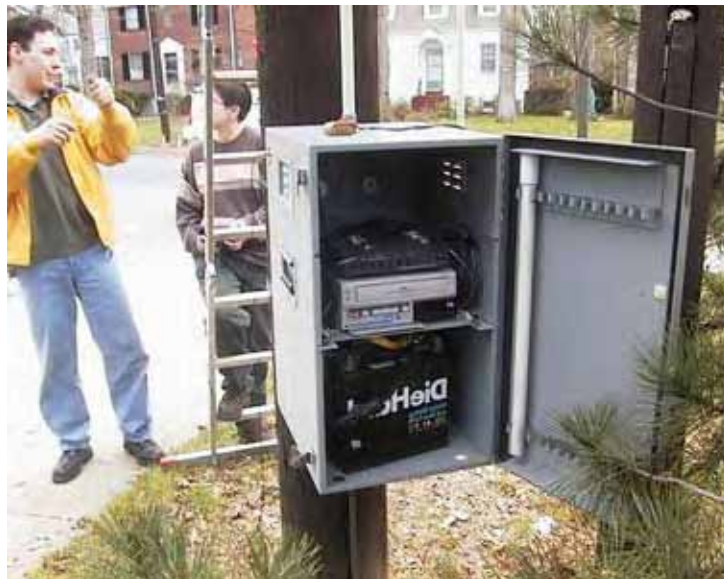
**Figure 3.** Portable Archival Traffic History (PATH) video system.

The taped recordings were taken back to the office and reduced. From the tapes, trained observers recorded pedestrian start-up times, pedestrian walking speeds, and pedestrian signal compliance. The observations were stratified for younger pedestrians and older pedestrians. The cameras were positioned to provide a close-up view of each pedestrian as he or she crossed the intersection. The observers were trained to look at physical attributes such as hair color and skin to determine age. This age classification was based on the visual inspection of the observer and should be considered an approximation.

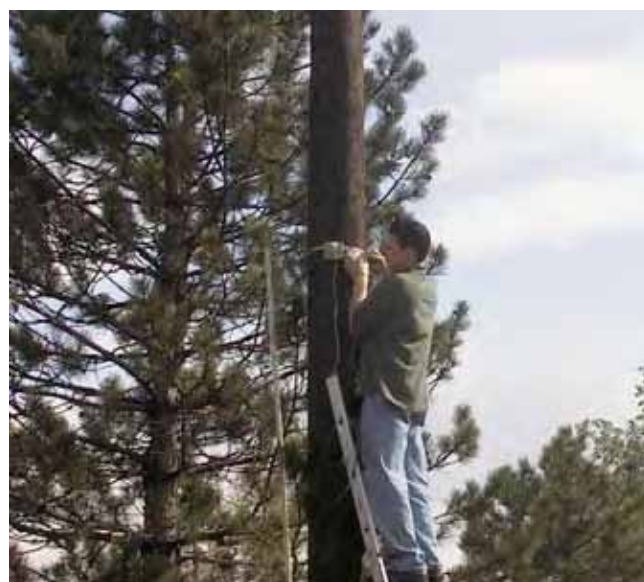
**Figure 4.** Field deployment of the PATH camera video system.

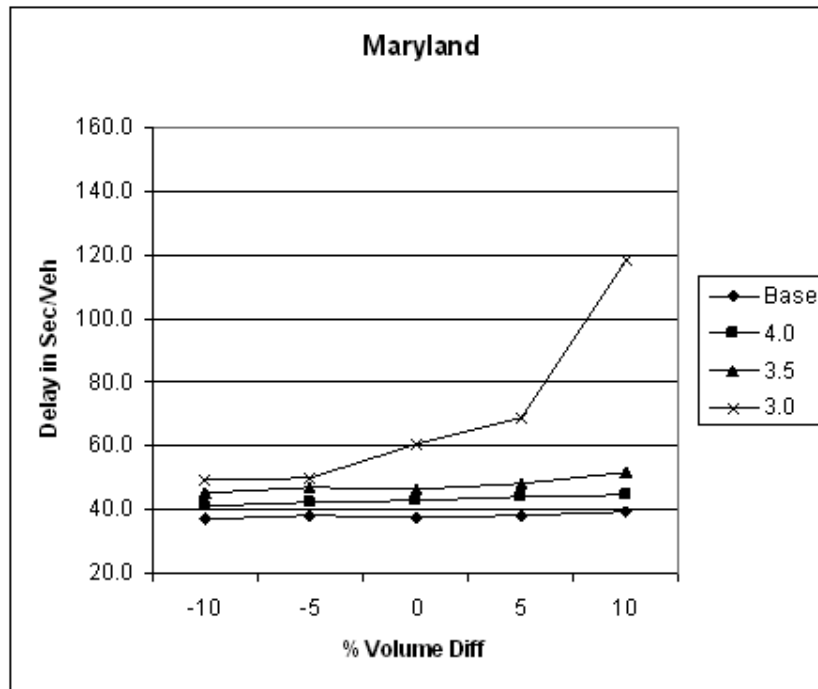
**Figure 10.** Delay vs. volumes at Montgomery County, Maryland case study intersection for walking speeds of 3.00, 3.50, 4.00 ft./sec. and base conditions.

A discussion of LOS and AVD for the major and minor approaches is included in Appendix E to this report. Table E-12 and Figures E-5, E-6, and E-7 in Appendix E show intersection delay for major and minor street approaches at walking speeds of 3.00, 3.50, and 4.00 ft./sec. at the Montgomery County case study intersection.

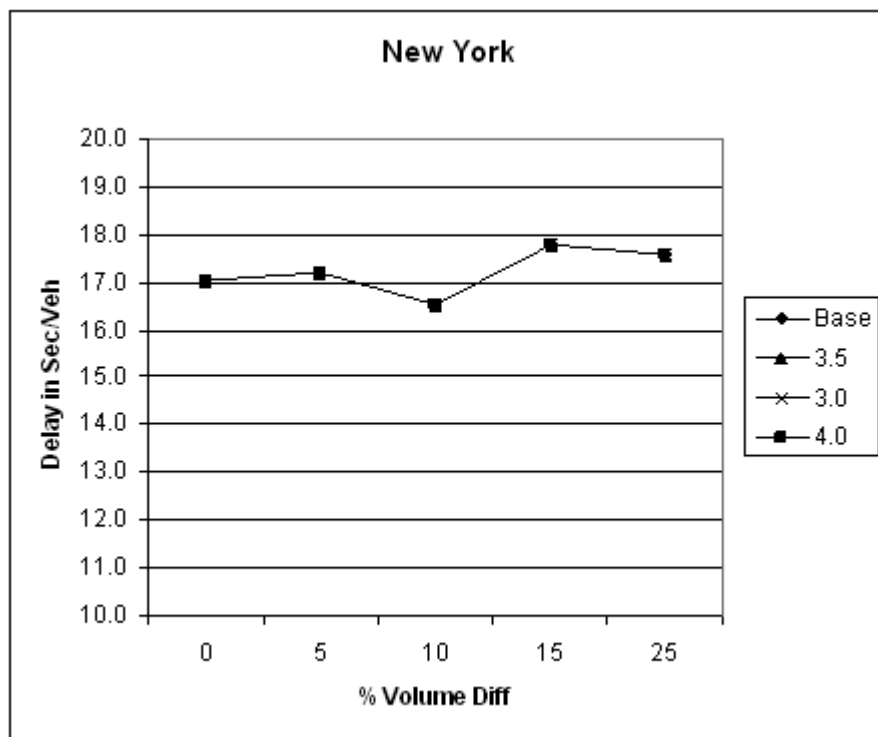
**Figure 11.** Delay vs. volumes at White Plains, New York case study intersection for walking speeds of 3.00, 3.50, 4.00 ft./sec. and base conditions.

LOS and AVD for the major and minor approaches are included in Table F-12 in Appendix F to this report.

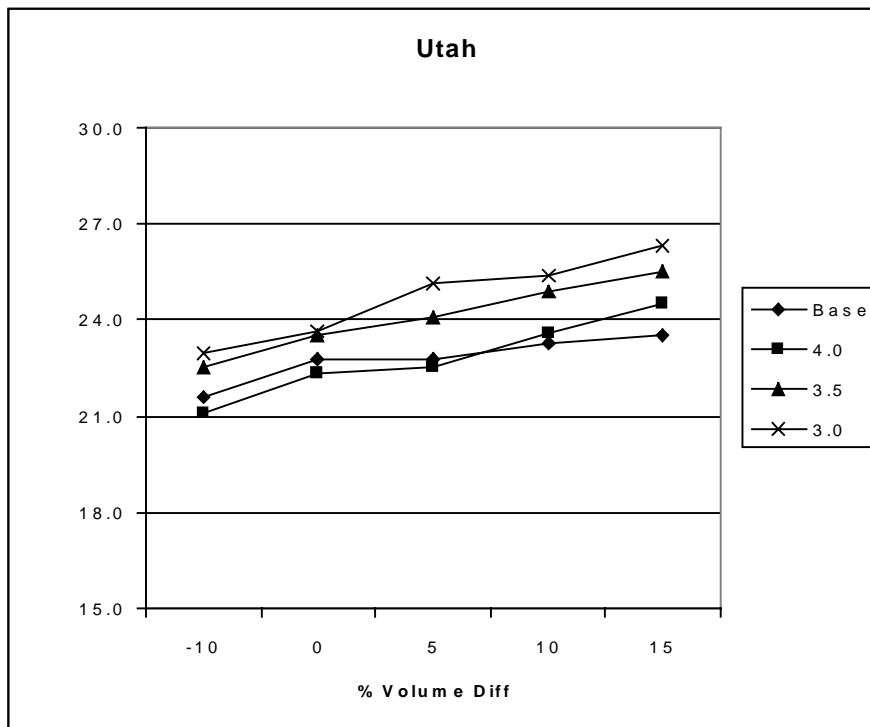
**Figure 12.** Delay vs. volumes at Salt Lake City, Utah case study intersection for walking speeds of 3.00, 3.50, 4.00 ft./sec. and base conditions.

A discussion of LOS and AVD for the major and minor approaches is included in Appendix G to this report. Table G-12 and Figures G-4, G-5, and G-6 in Appendix G show intersection delay for major and minor street approaches at walking speeds of 3.00, 3.50, and 4.00 ft./sec. at the Salt Lake City case study intersection.

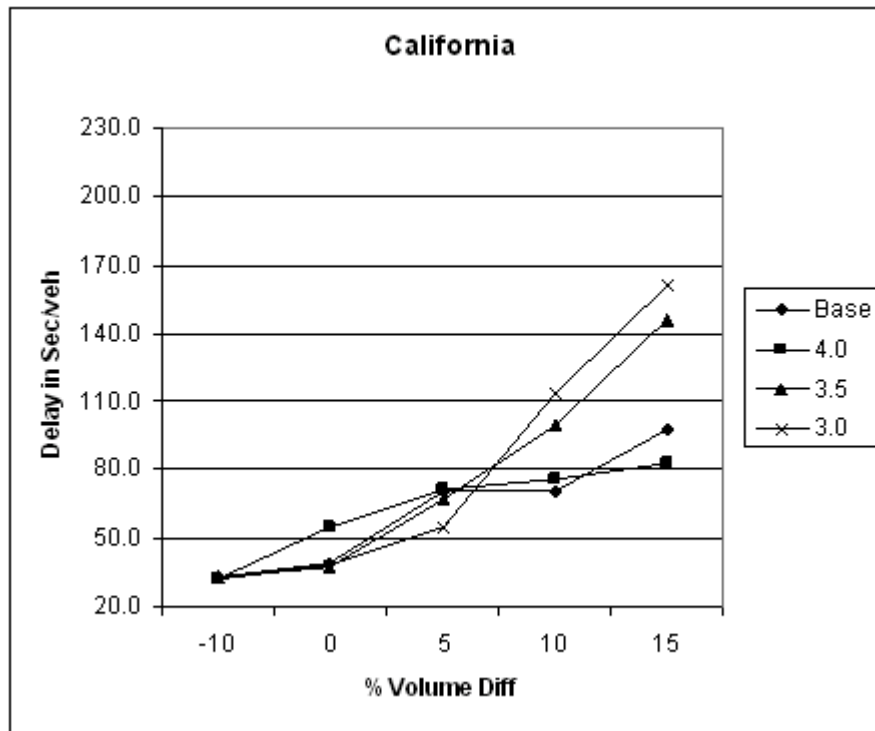
**Figure 13.** Delay vs. volumes at Orange County, California case study intersection for walking speeds of 3.00, 3.50, 4.00 ft./sec. and base conditions.

A discussion of LOS and AVD for the major and minor approaches is included in Appendix H to this report. Table H-12 and Figures H-3, H-4, and H-5 in Appendix H show intersection delay for major and minor street approaches at walking speeds of 3.00, 3.50, and 4.00 ft./sec. at the Orange County case study intersection.

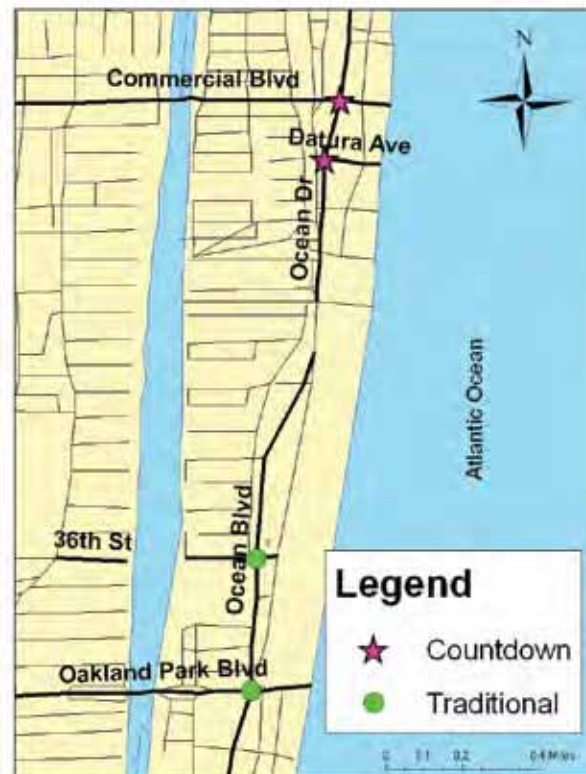
**Figure C-1.** Study intersections in Broward County, Florida.

Figure C-1 displays the type of pedestrian signal at each of the four intersections. As shown, the intersections were in close proximity to one another and were located along the Ocean Boulevard/A1A corridor. The two farthest intersections were located 1.5 miles apart. The land use surrounding these intersections was characterized by office buildings, restaurants, and commercial storefronts. There also were a few senior high-rise communities toward the southern end of the corridor.

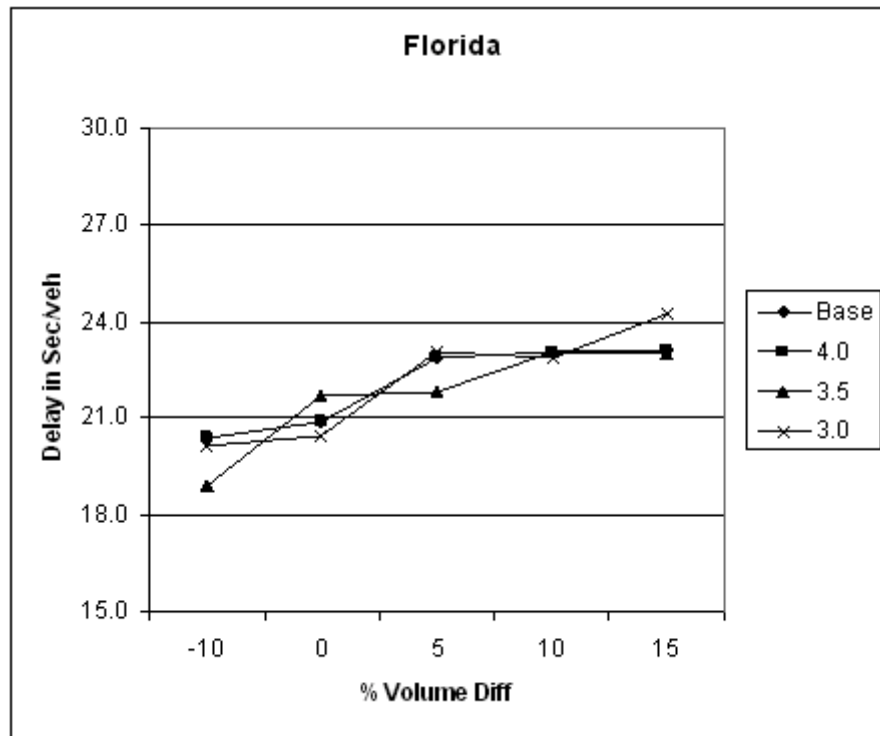
**Figure C-2.** Delay vs. volumes at case study intersections for walking speeds of 3.00, 3.50, 4.00 ft./sec. and base conditions.

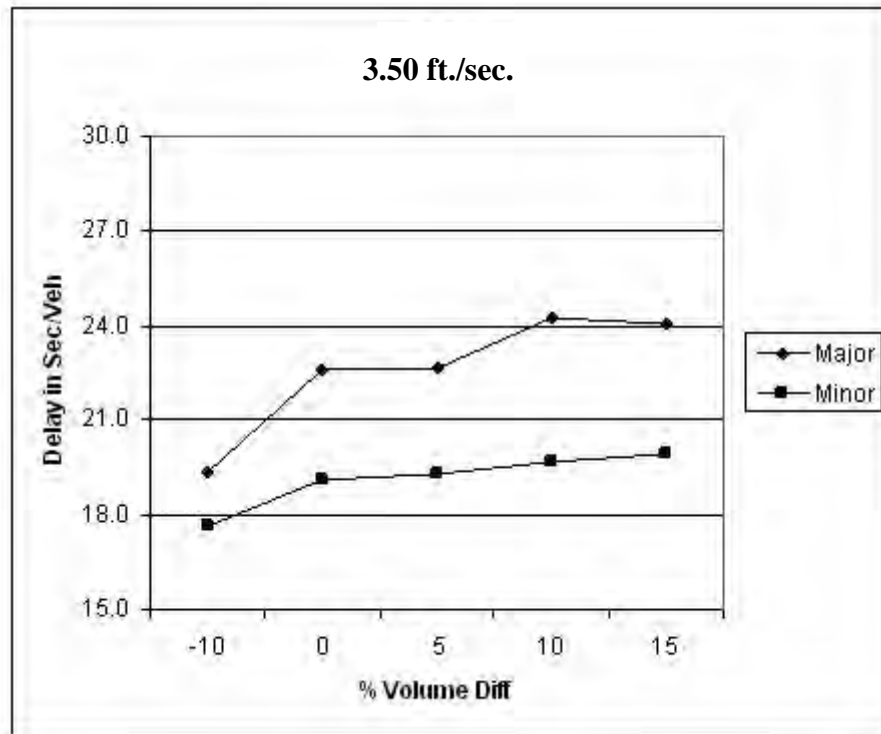
**Figure C-4.** Intersection delay for major and minor street approaches, 3.50 ft./sec. walking speed, Broward County, Florida.

A discussion of LOS and average vehicle delay (AVD) for the major and minor approaches is included in Appendix C to this report. Table C-13 and Figures C-3, C-4, and C-5 in Appendix C show intersection delay for major and minor street approaches at walking speeds of 3.00, 3.50, and 4.00 ft./sec. at the Broward County case study intersection.

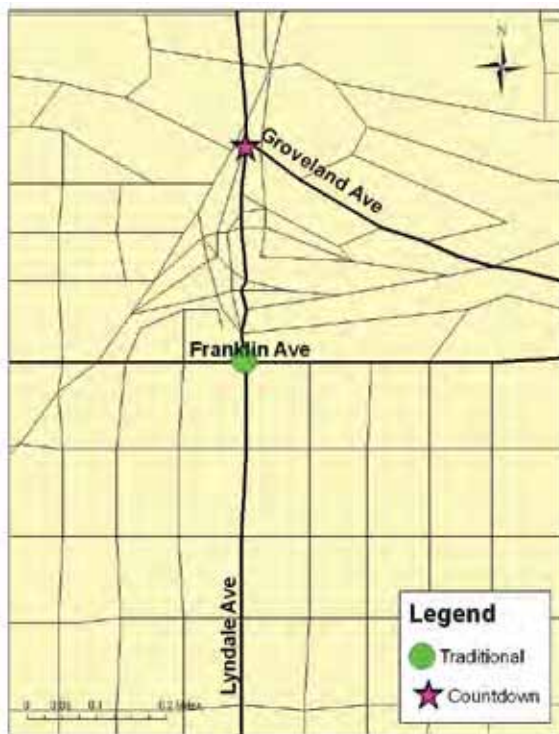
**Figure D-2.** Signalized intersections in Minneapolis, Minnesota.

Figure D-2 illustrates the two Minneapolis intersections. Figure D-3 illustrates the two St. Paul intersections. The figures display the type of pedestrian signal at each of the four intersections. As shown, for each of the cities, the intersections were in close proximity to one another. The two Minneapolis intersections were approximately one-third-mile apart; the two St. Paul intersections were approximately one-half-mile apart. The Minneapolis intersections were located near a center for the visually impaired.

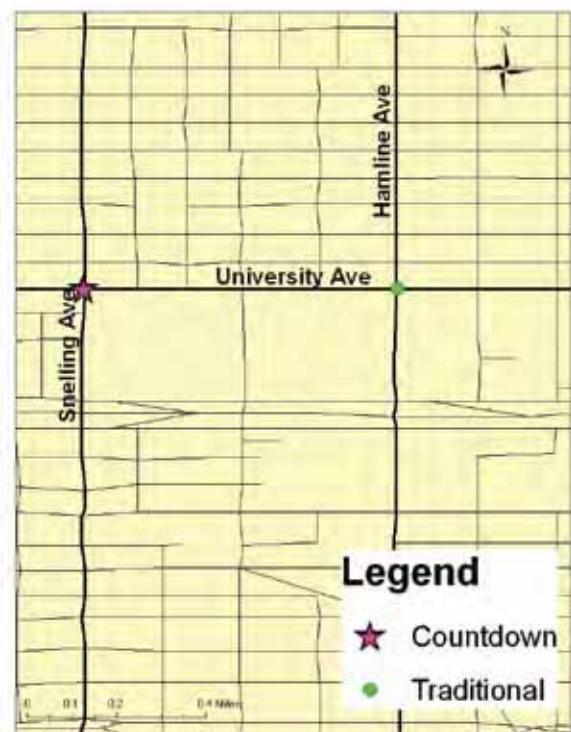
**Figure D-3.** Signalized intersections in St. Paul, Minnesota.

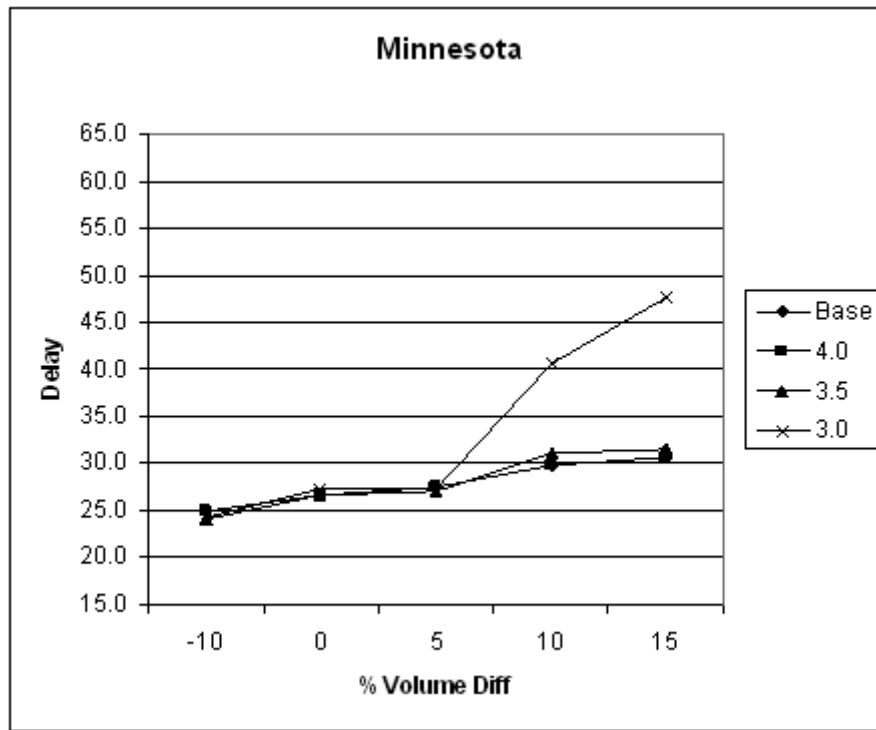
**Figure D-4.** Delay vs. volumes at case study intersections for walking speeds of 3.00, 3.50, 4.00 ft./sec. and base conditions.

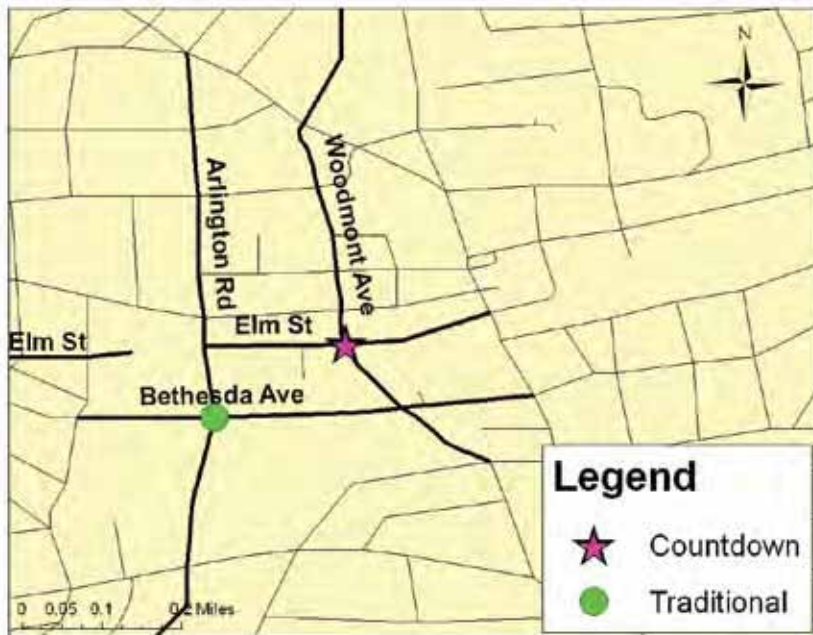
**Figure E-2.** Study intersections in Bethesda, Maryland.

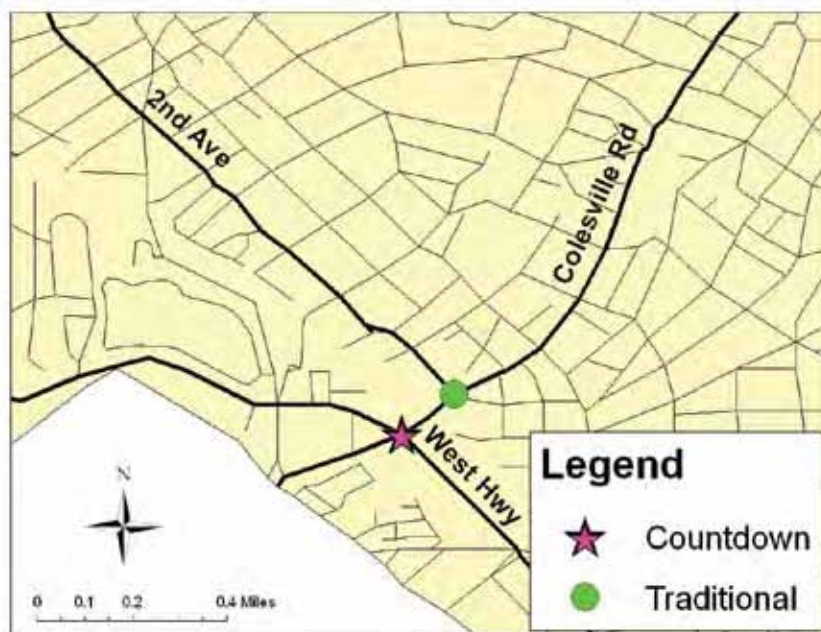
**Figure E-3.** Study intersections in Silver Spring, Maryland.

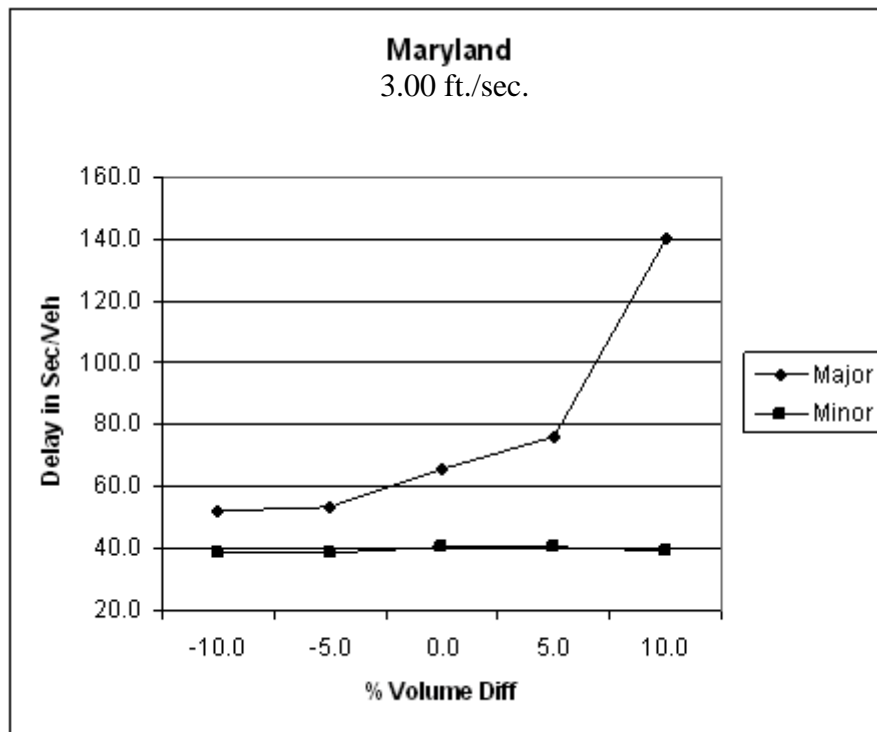
**Figure E-5.** Intersection delay for major and minor street approaches, 3.00 ft./sec. walking speed, Montgomery County, Maryland.

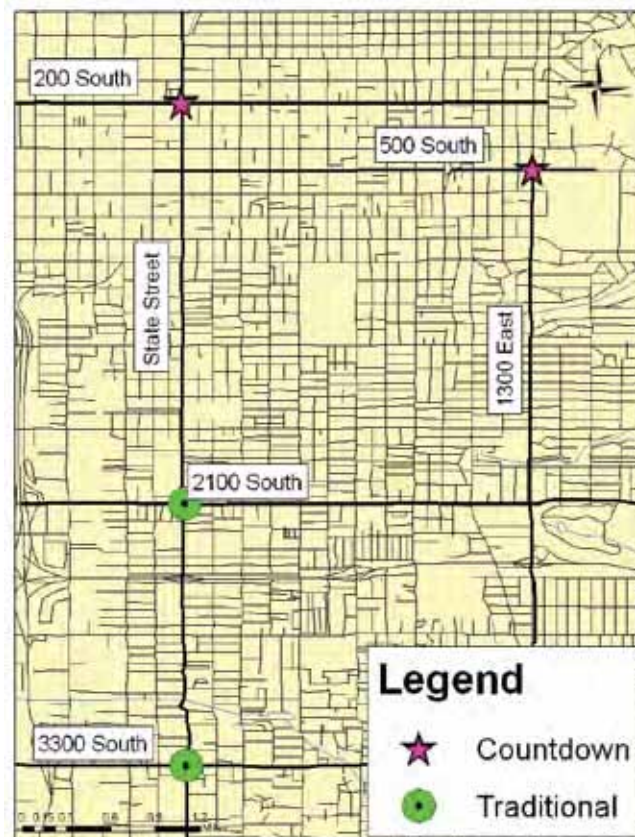
**Figure G-2.** Study intersections in Salt Lake City, Utah.
