Web-Only Document 117A:

Accessible Pedestrian Signals: A Guide to Best Practices

Contractors Guide for NCHRP Project 3-62
Submitted June 2007

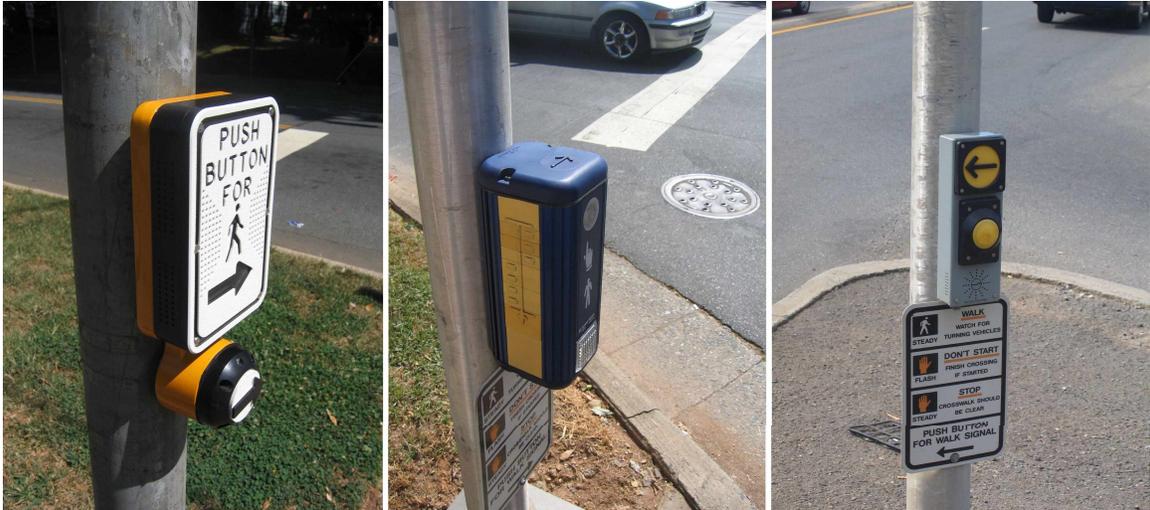
Figure 1-1. Examples of pushbutton-integrated accessible pedestrian signals from various manufacturers.

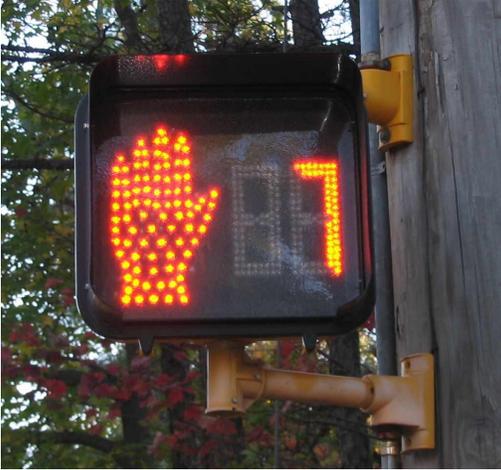
- The countdown signal supplements the “Walk/Don’t Walk” signals; it does not replace them.
- MUTCD guidance stipulates that the countdown should only be displayed during the flashing “Don’t Walk” interval because of inconsistencies of the countdown during the “Walk” interval at actuated signals. Nonetheless, many cities are still using signals that display the countdown during the “Walk” interval (see Figure 3-9). Pedestrians with low vision have had problems distinguishing the countdown numbers from the orange flashing hand symbol when they are displayed alongside the white symbol of a man walking.

Figure 3-8. Correct display of pedestrian countdown signal (counting down during flashing “Don’t Walk”).

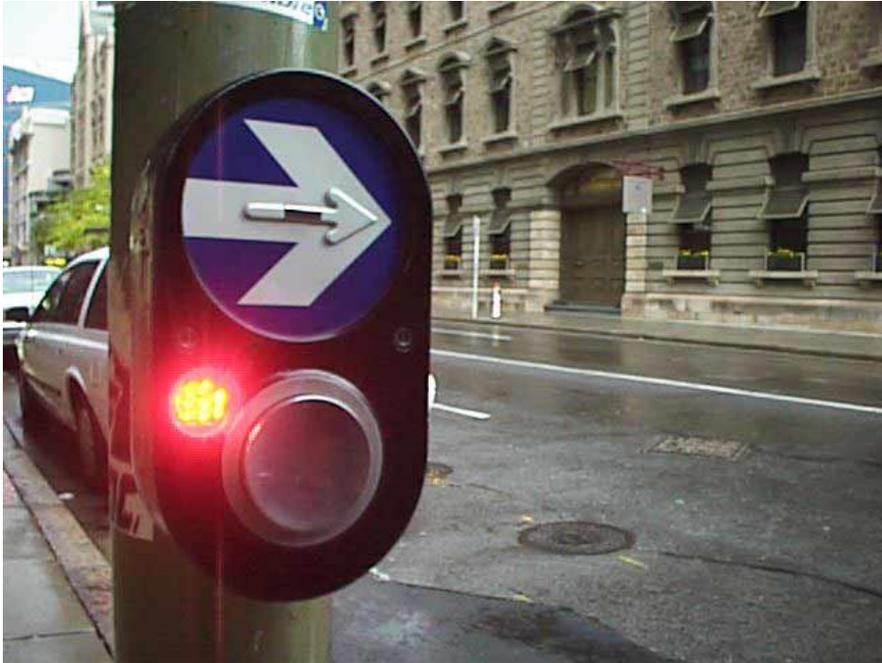
Figure 4-3. The tactile arrow above the pushbutton on this accessible pedestrian signal is superimposed on a larger visual arrow.

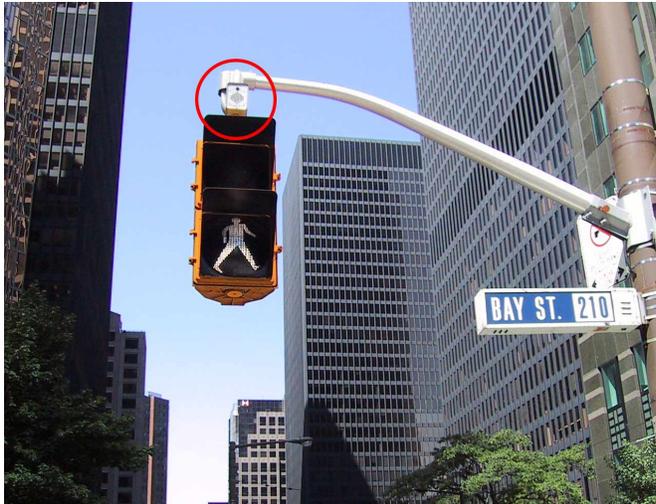
In that case, a pedhead-mounted APS without a pushbutton or locator tone may be more appropriate. However, a “Walk” message or tone and volume levels should be carefully determined to avoid confusion to pedestrians and to prevent disturbance to neighbors. Unless audible beeping is determined to be necessary, the APS speaker should be oriented down toward the pedestrian waiting location. Use of a small mast arm to locate the APS over the crosswalk location might be appropriate (Figure 6-4).

Figure 6-4. The mast arm is used in this installation in Toronto, Canada, to position the pedestrian signal head and speaker closer to the crosswalk.

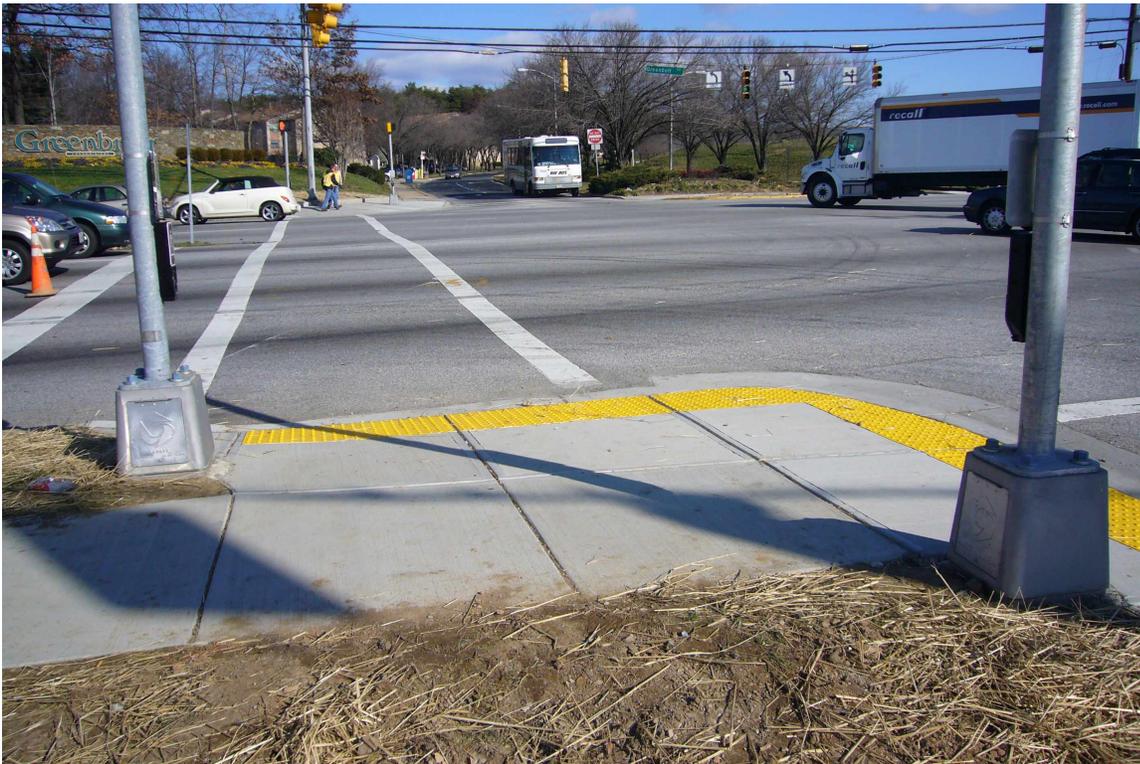
In addition, clear floor or ground space at the pushbutton shall connect to, or overlap, the pedestrian access route.

Figure 6-7. APS installation in new construction.

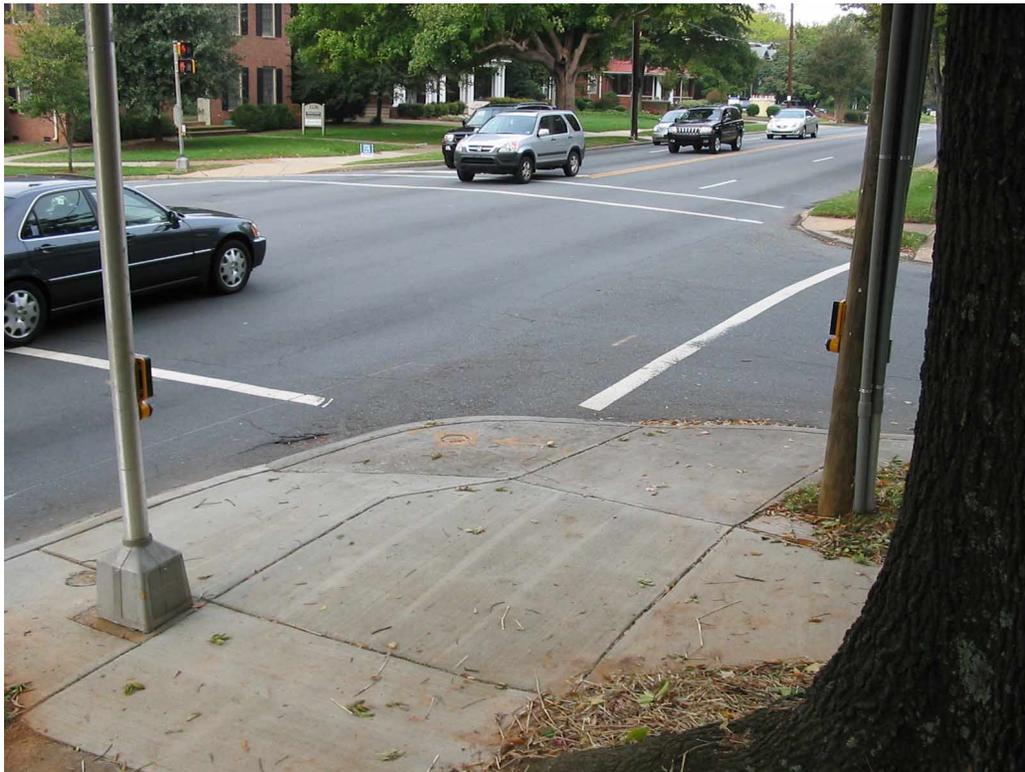
Figure 6-10. The APS should be located on the intersection side of the pole, as shown in this photo.

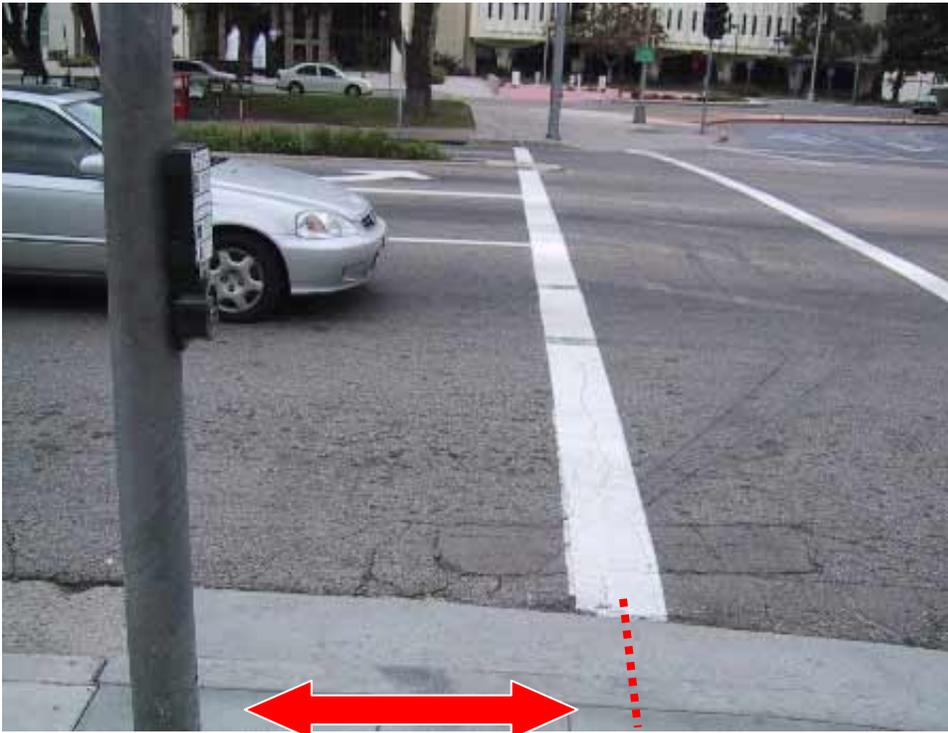
Figure 6-11. The MUTCD states that the APS should be within 5 ft of the crosswalk line extended.

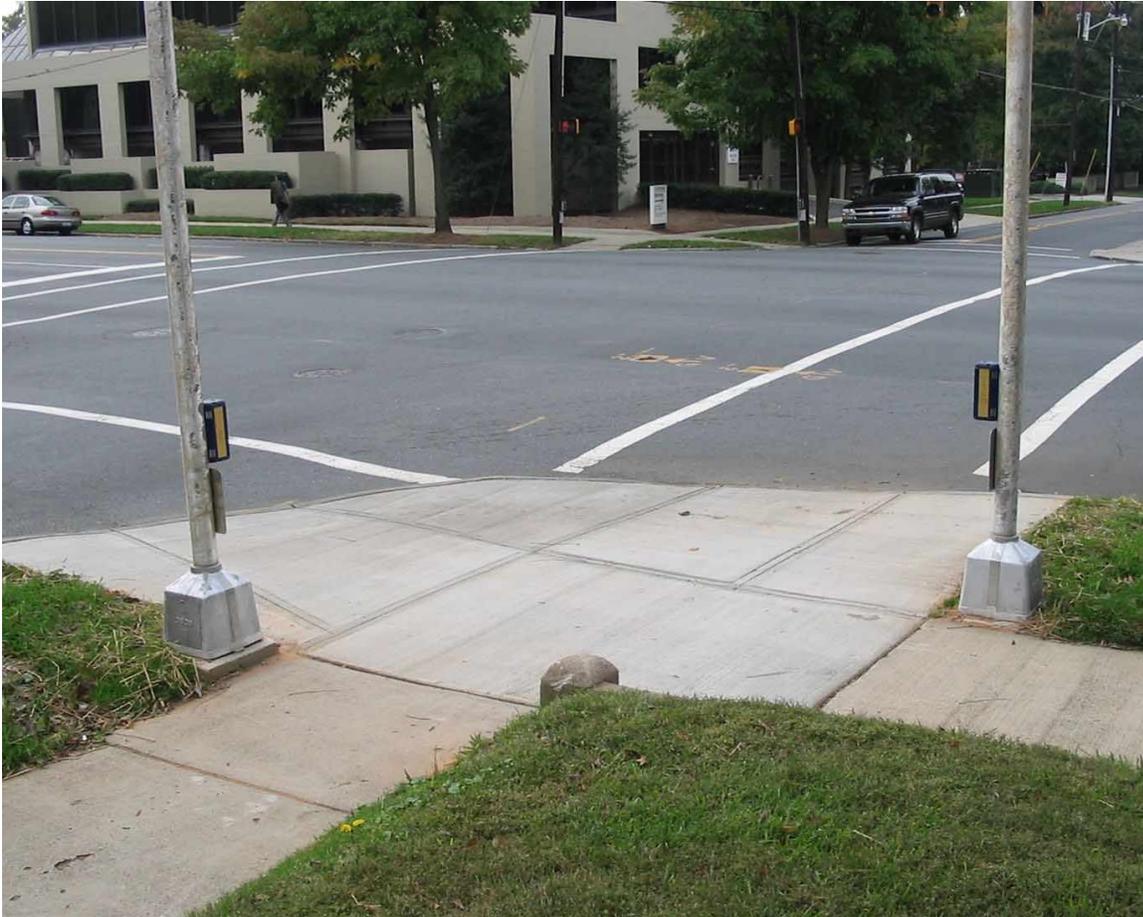
Figure 6-13. APSs installed in this reconstruction location are in accordance with the Draft PROWAG in that they are beside a level landing and separated from each other by at least 3 m. Both APS devices are located on the intersection side of their poles.

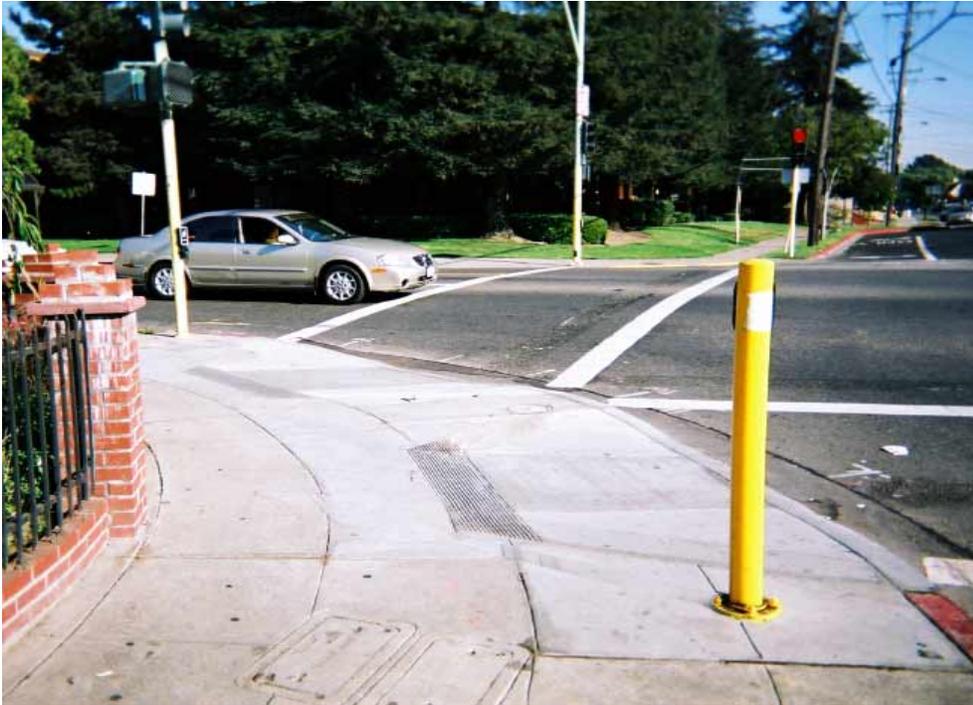
Figure 6-16. APSs are positioned appropriately at this intersection by the addition of a stub pole for one crosswalk. The stub pole holding the APS for the crosswalk at right is simply bolted to the sidewalk. The other APS is mounted on the pole that supports the pedhead.

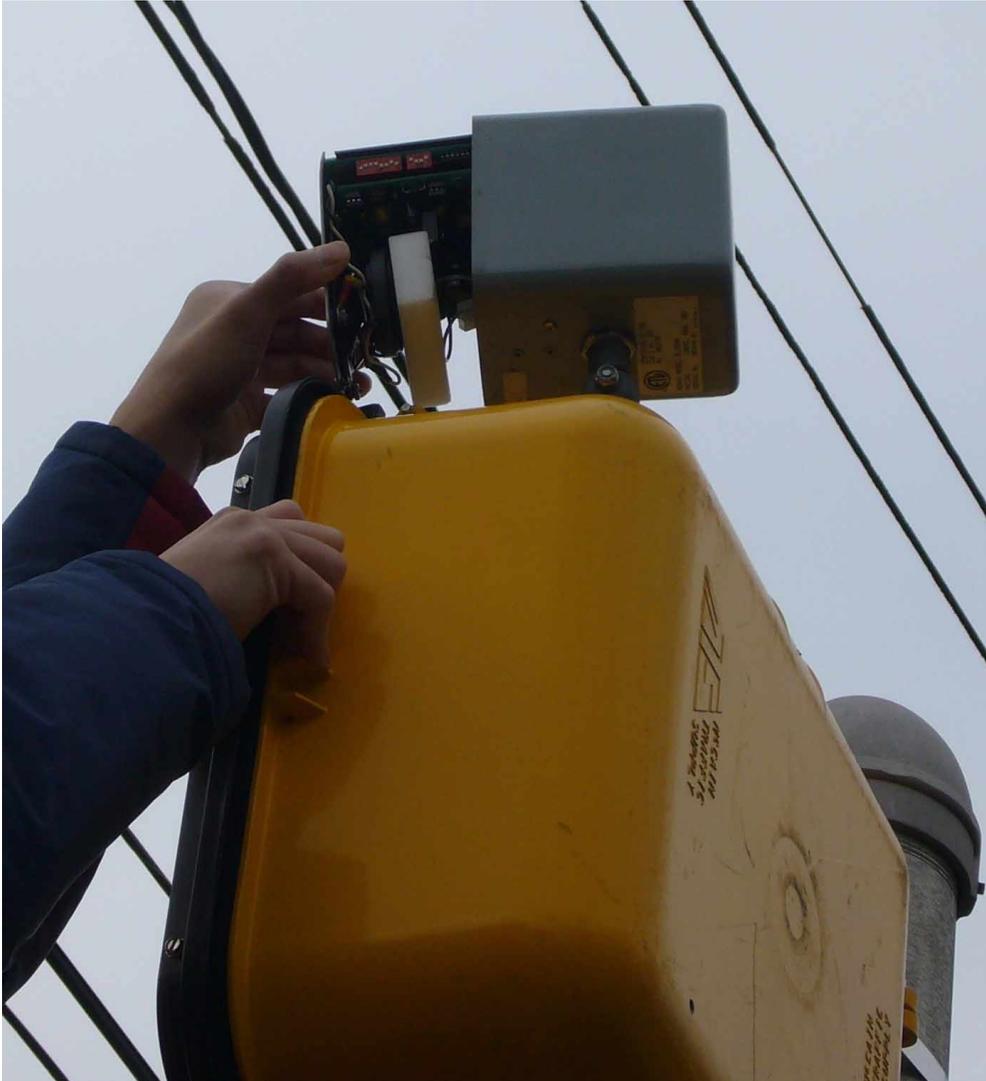
Figure 6-18. APS device with control board in pedhead (speaker opened for illustration).

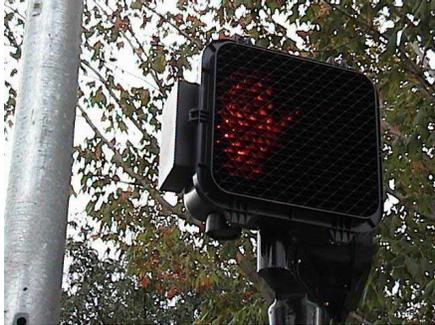
Figure 6-19. External mount for controller board is visible on the left side of the pedestrian signal head.

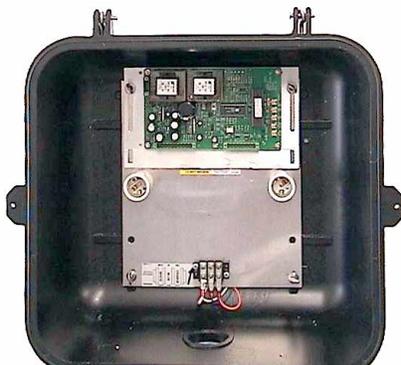
Figure 6-20. Controller board mounted behind 18-in. pedestrian signal head.

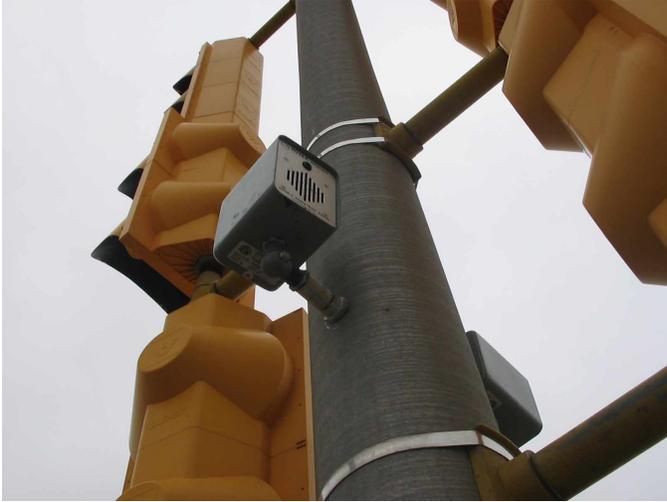
Figure 6-21. APS speaker mounted directly to the metal pole provides more support during high wind.

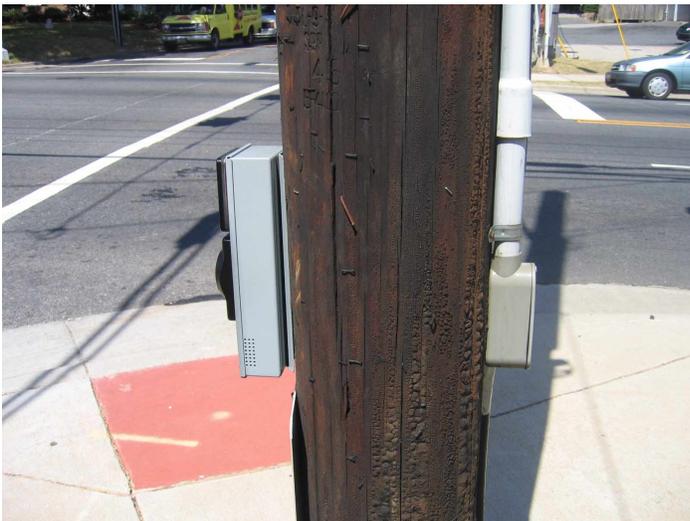
Figure 6-25. This APS is mounted on a wooden pole by drilling a hole through the pole and running wires through the back of the device.

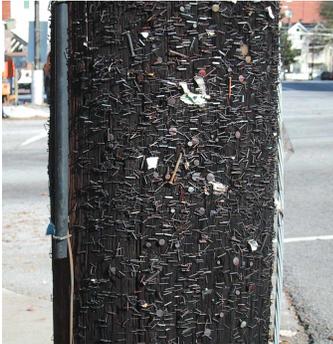
Figure 6-26. Wooden pole with nails and staples that are a source of concern.

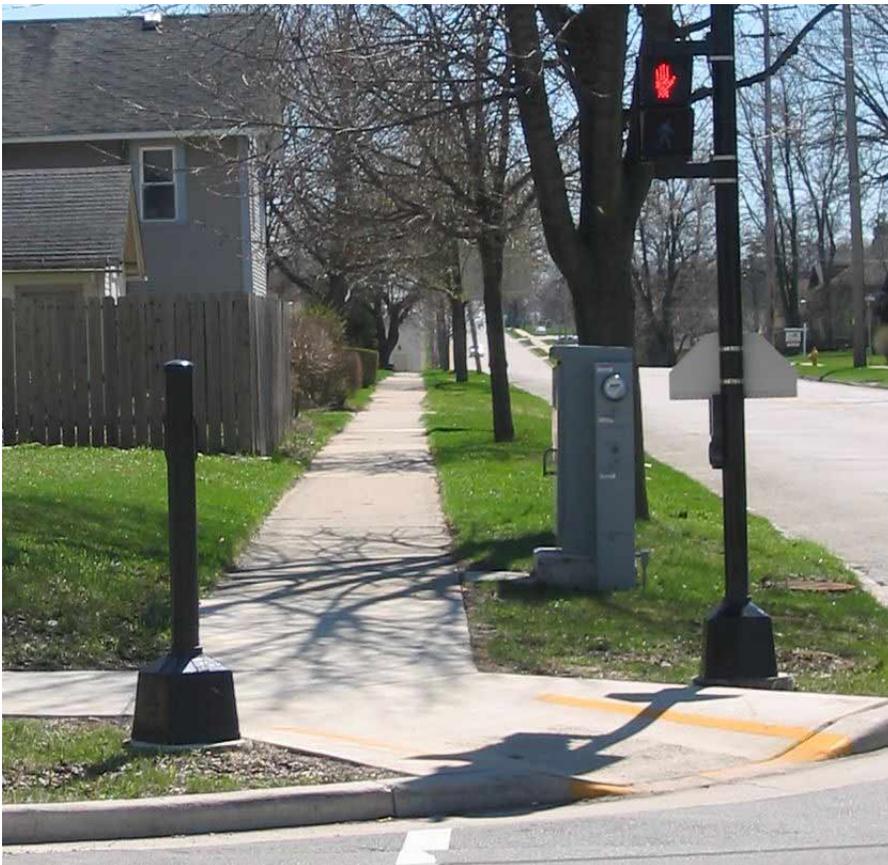
Figure 6-31. Stub pole example.

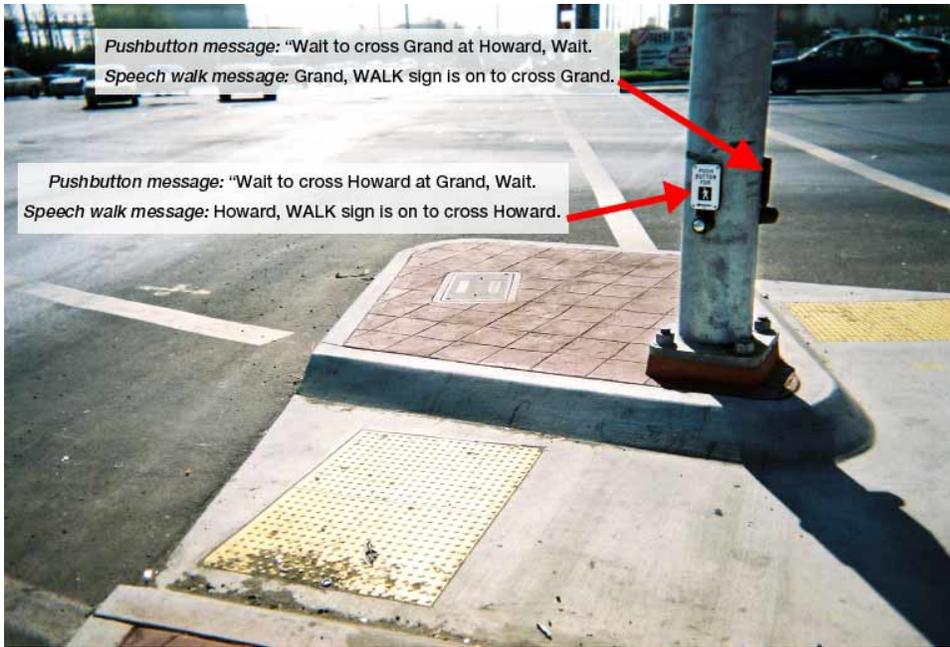
Figure 6-52. Example of pushbutton information messages and speech “Walk” messages for two APSs located on the same pole.

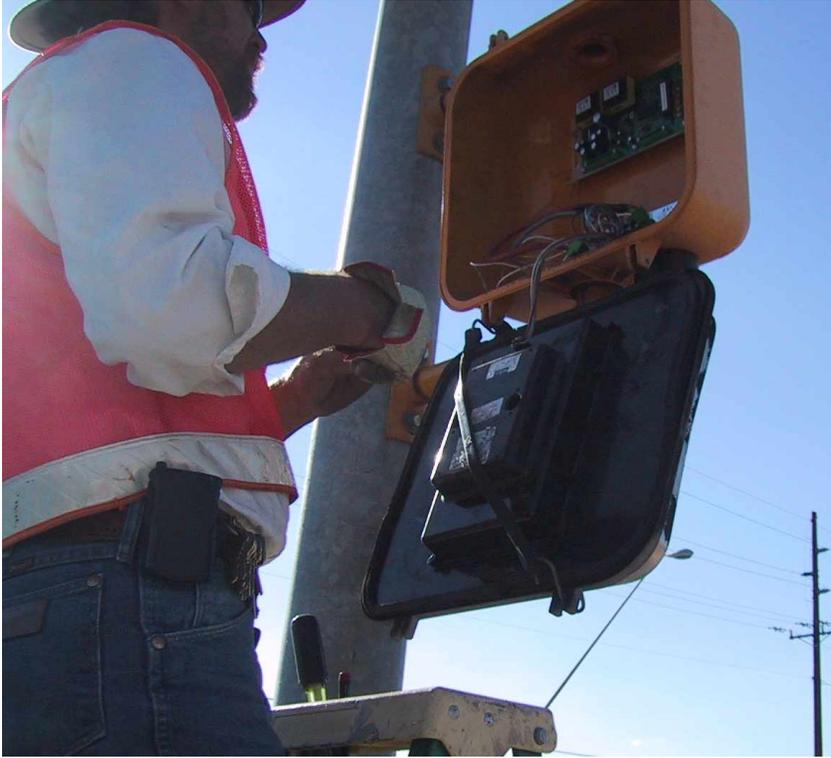
Figure 7-2. Technician installing APS control board in pedhead.

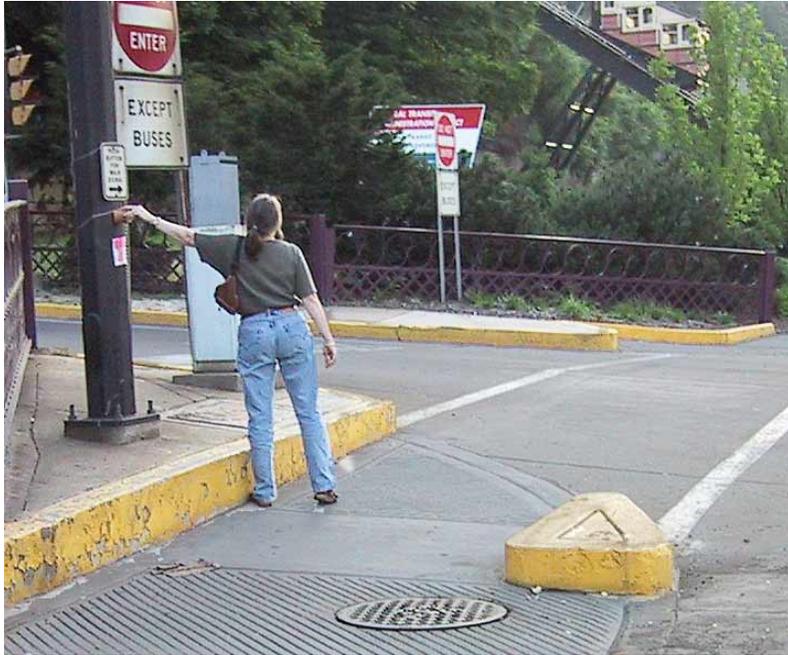
Figure 7-3. This pushbutton may be 42 in. from the bottom of the pole, but it is almost 60 in. above the landing, making it inaccessible to a wheelchair user and not likely to be located by a person who is blind.

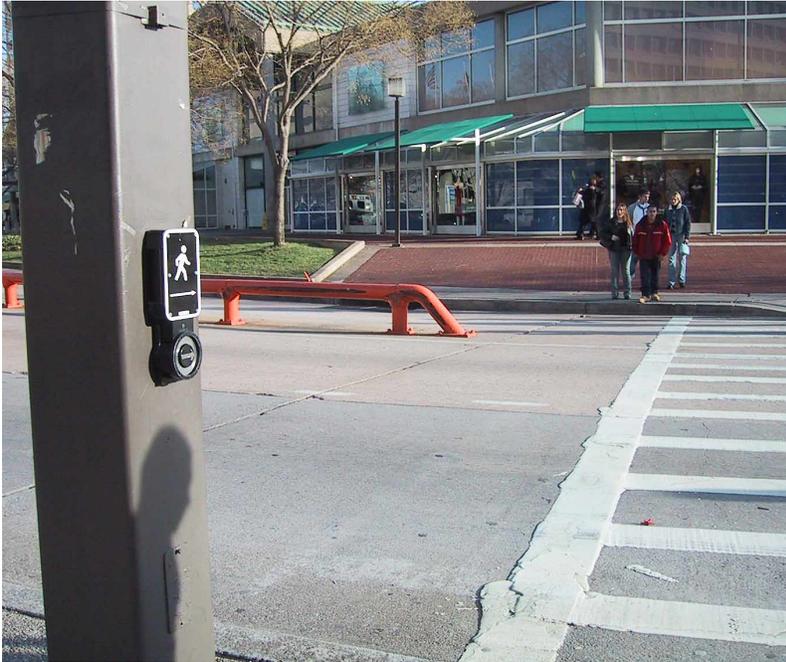
Figure 7-5. Well-located APS on a square pole.

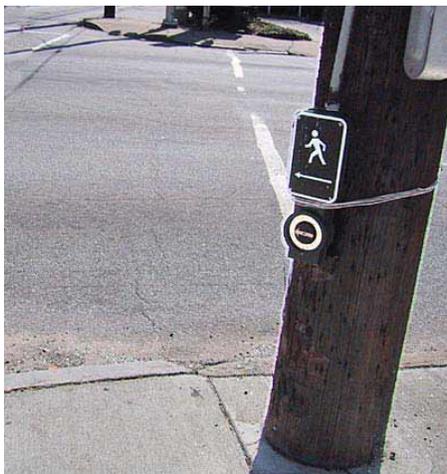
Figure 7-13. The APS was temporarily replaced on the pole, but the tactile arrow points to the center of the intersection, rather than being aligned with the direction of travel on the crosswalk.

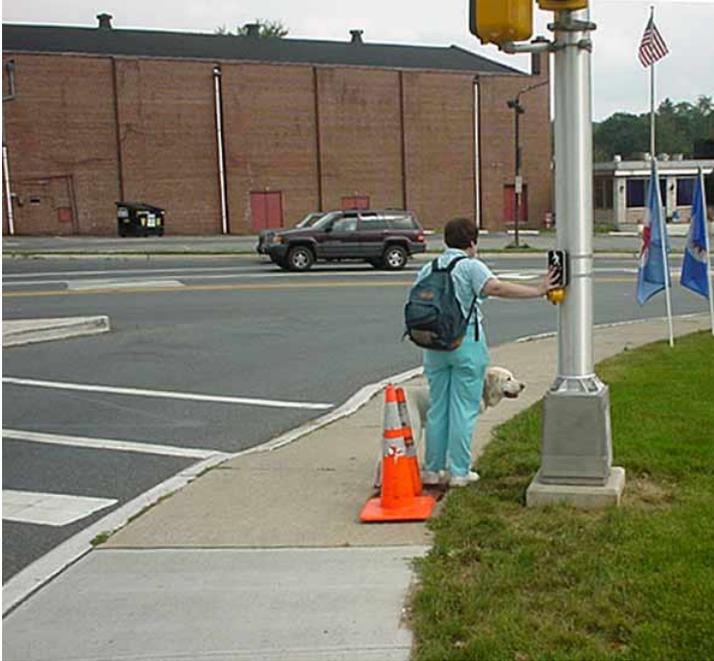
Figure 9-9. APS mounted on signal pole for crossing signaled right-turn lane. A pedestrian who is blind is waiting with her hand on the pushbutton for the vibrotactile “Walk” indication. After the “Walk” indication begins, she must turn and cross the sidewalk before beginning to cross the street.

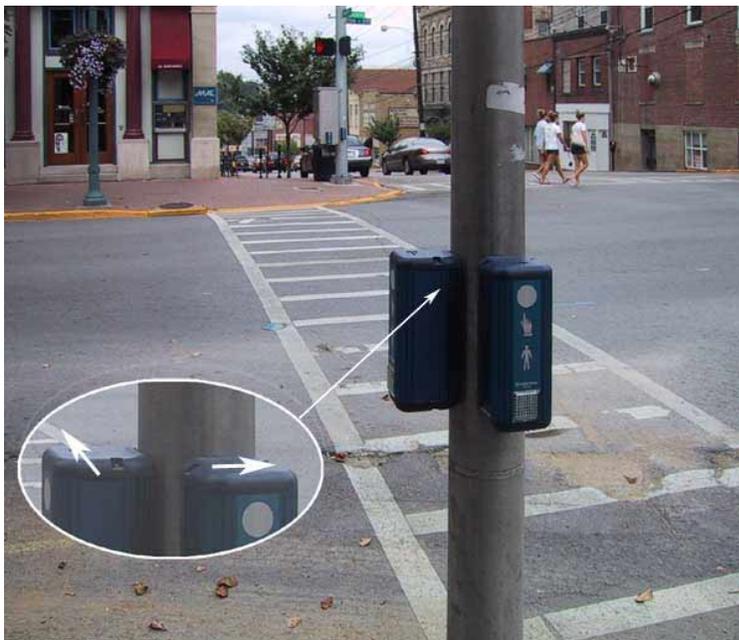
Figure 9-10. Mounting of two Prisma pushbutton units on a single pole. See arrows on insert detail for the orientation of the tactile arrow on the top of each unit. Both devices make the same sound during the “Walk” indication, which is acceptable in this installation since there is exclusive pedestrian phasing.

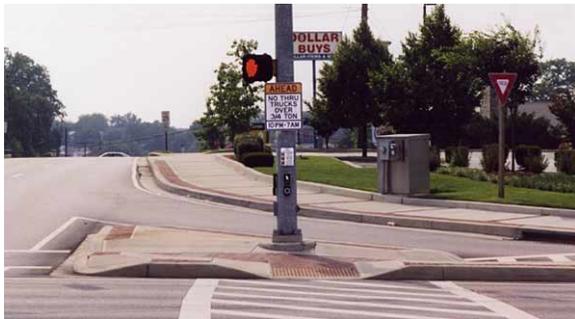
Figure 9-12. Two APSs are mounted on the existing pole on this island.

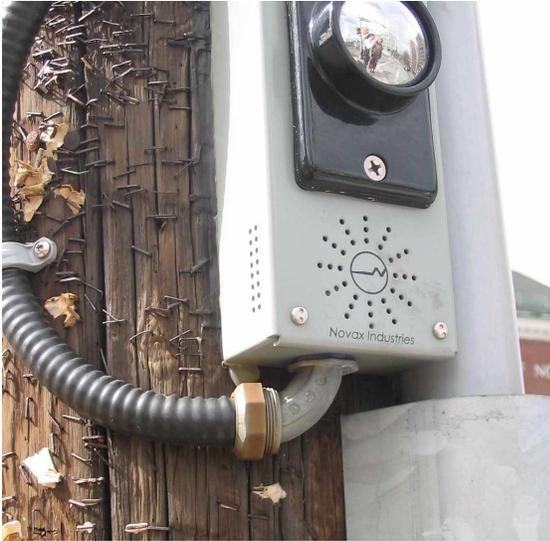
Figure 9-20. APS pushbutton mounted on wooden pole, showing conduit installed into the bottom of the pushbutton device.

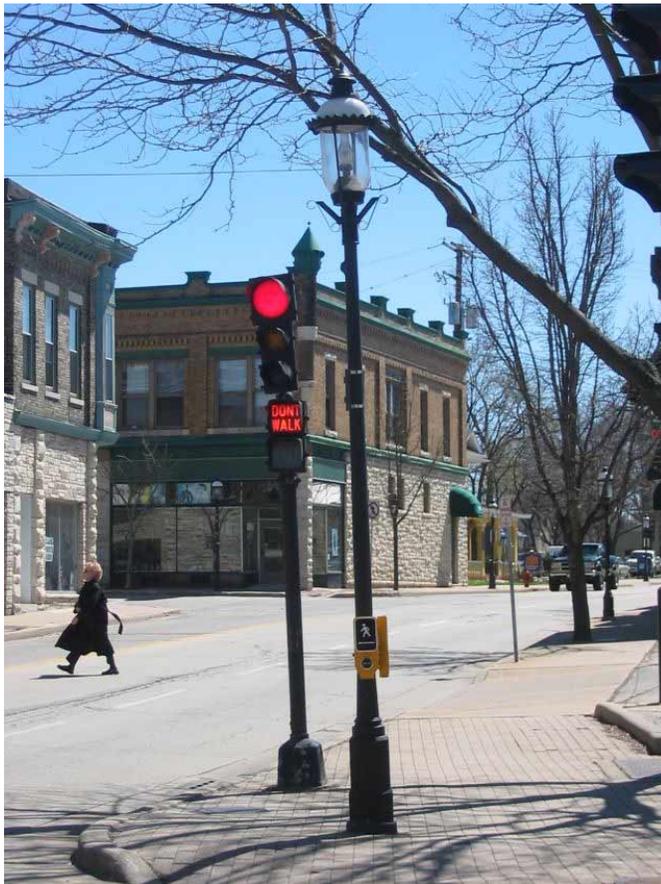
Figure 9-22. APS mounted on lamppost.

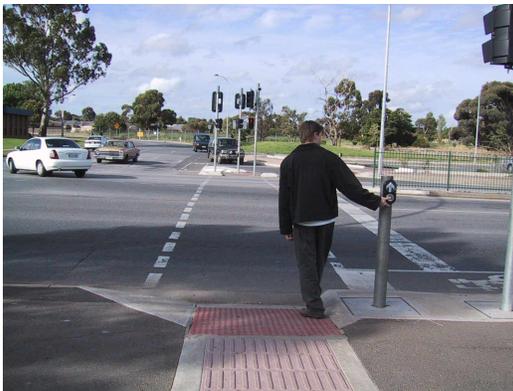
Figure 10-8. Typical APS location in relation to the crosswalk and sidewalk. Australian curb ramp standards allow a steeper slope than allowed by U.S. standards.

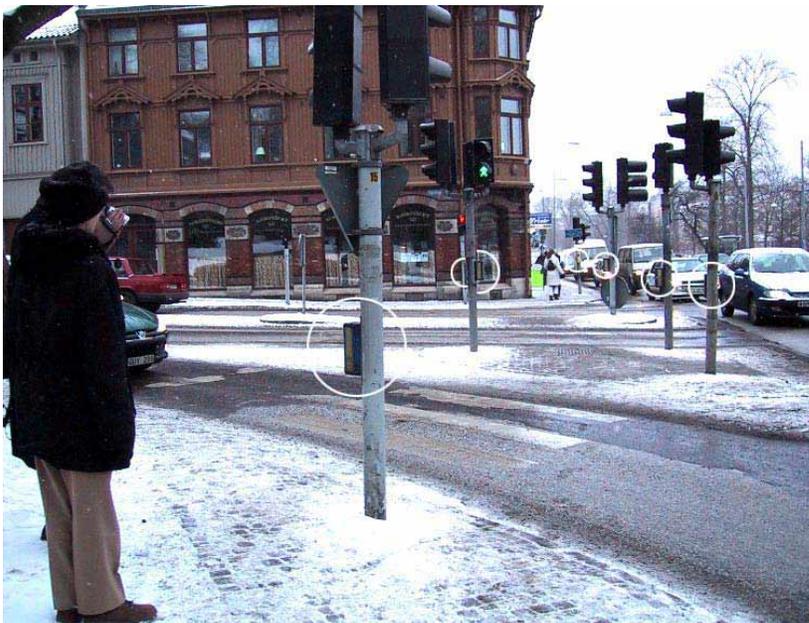
Figure 10-11. This street crossing in Göteborg, Sweden, includes two islands and numerous APSs (indicated in the photo by circles or half-circles).

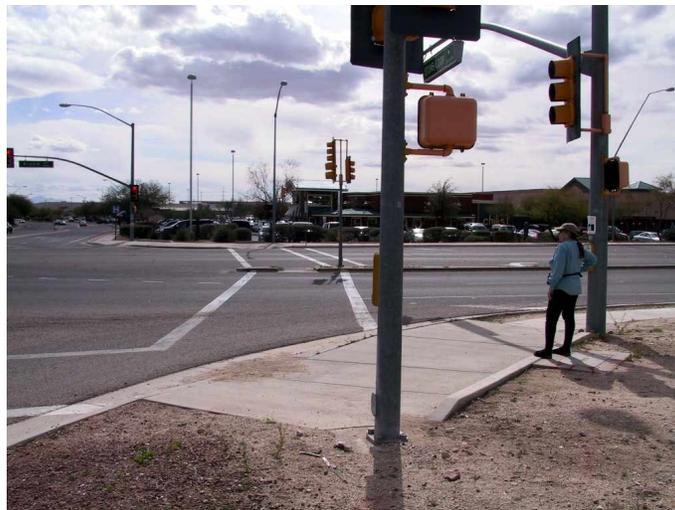
Figure D-7. This crosswalk is defined as skewed because it is timed for median crossing (two-stage), and a blind pedestrian might miss the median due to the bent crosswalk.
